Loss of Thrust in Both Engines After Encountering a Flock of Birds and Subsequent Ditching on the Hudson River

US Airways Flight 1549
Airbus A320-214, N106US
Weehawken, New Jersey
January 15, 2009

NTSB/AAR-10/03
PB2010-910403

Aircraft Accident Report

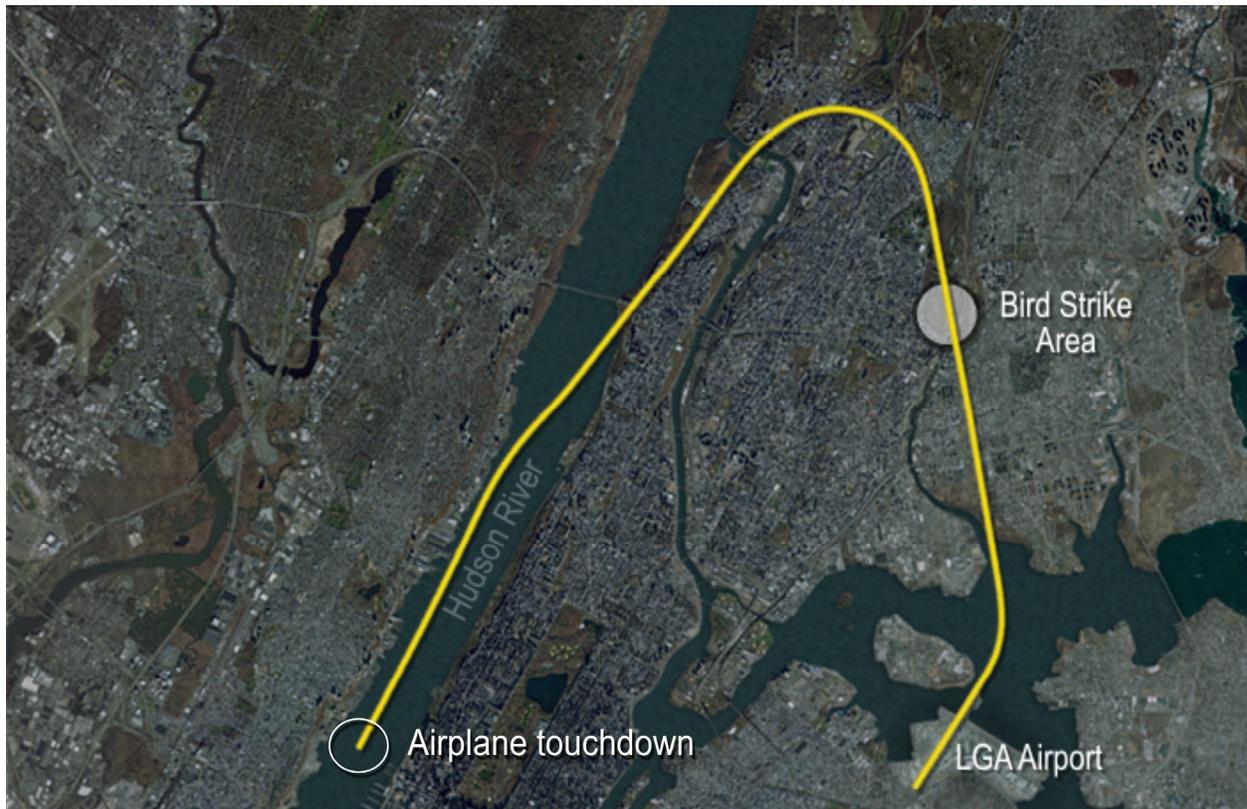
Figure 1. Flight track of the airplane.

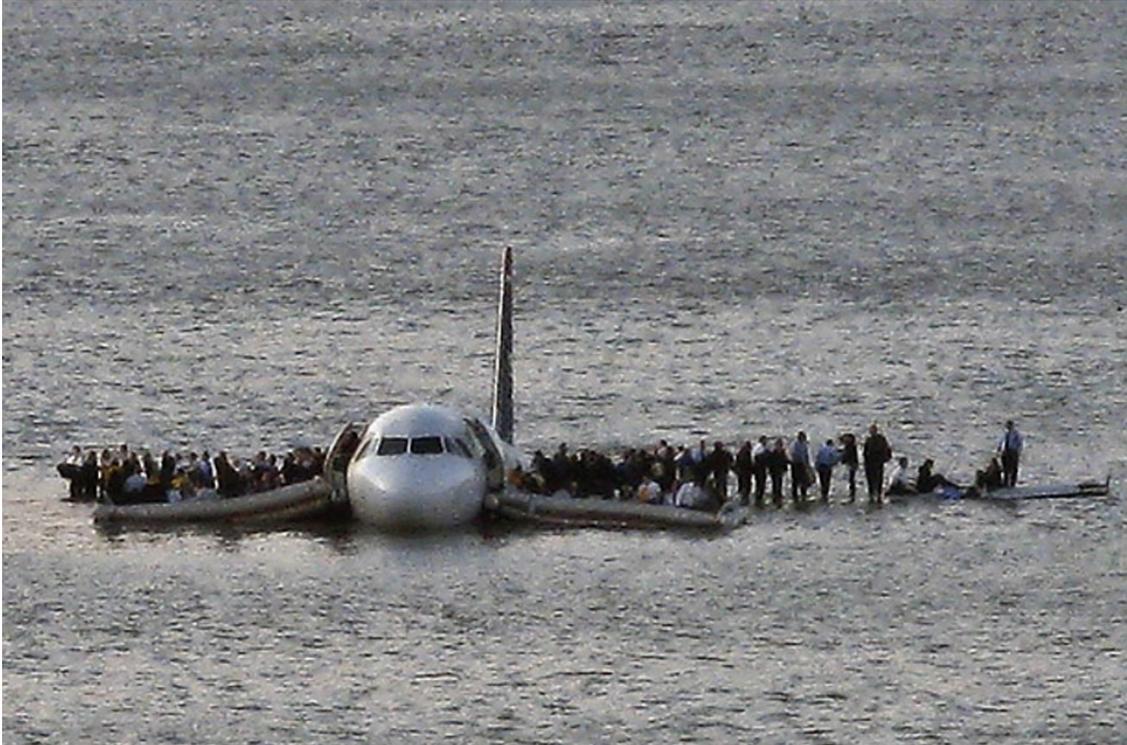
Within seconds after the ditching on the Hudson River, the crewmembers and passengers initiated evacuation of the airplane. Subsequently, all of the occupants were evacuated from the airplane and rescued by area responders. (See sections 1.15.5 and 1.15.6 for information about the emergency evacuation and response, respectively.) Figure 2 shows the airplane occupants on the wings and in the slide/rafts after the evacuation.

Figure 2. A photograph showing the airplane occupants on the wings and in the slide/rafts after the evacuation.

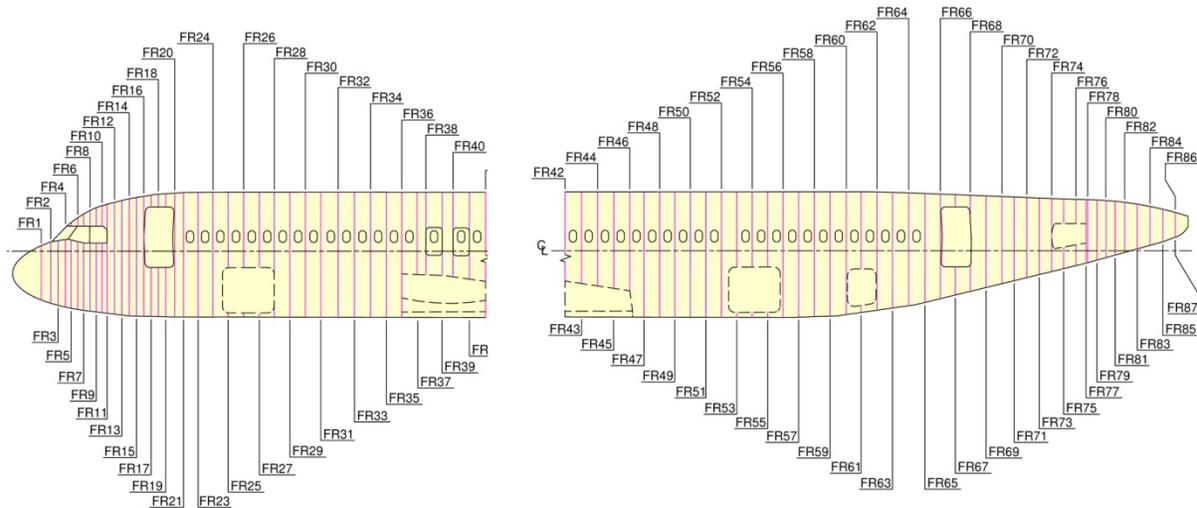
Specifically, portions of the left-side belly fairing aft of the wing were either fractured or missing. The right-side belly fairing was missing from FR37 to FR51. The lower left side of the rear fuselage was fractured between FR56 and FR64 and bent outward away from the airplane centerline. The lower right side of the rear fuselage was crushed and buckled inward from FR56 to FR70. The internal cargo structure was damaged, and the floor panels at FR57 were buckled upward.

Figure 6. Diagram showing the A320 fuselage frame locations.

The crossbeams from FR66 aft were sheared in the aft direction, but the longitudinal seat tracks remained in position. The lower third of the aft pressure bulkhead was sheared away, and the lower part of the fuselage was torn in the aft direction. The tail cone, including the APU, was separated from its attachment points to the fuselage, except for the right-side lower location, and no longer retained its conical shape.

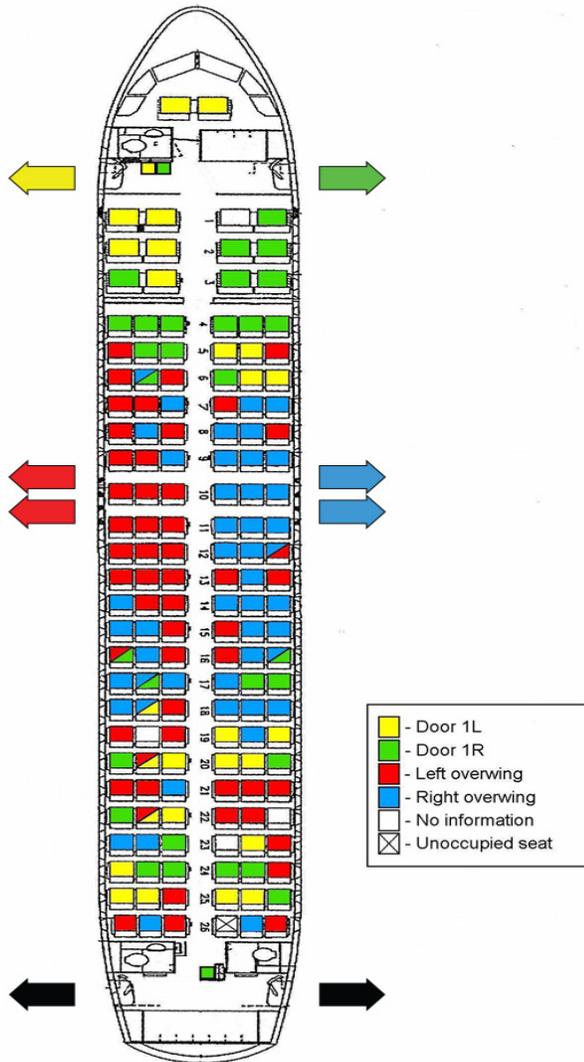
Figure 9. Occupant evacuation exit usage.

Note: Because of postevacuation passenger movement, the chart does not accurately indicate the locations where people were rescued. Additionally, several passengers exited the airplane, reentered, and exited the airplane a second time. These passengers' seat locations are designated with a '/'. The first exit used is represented by the upper color while the second exit is shown by the lower color.
