Loss of Thrust in Both Engines After Encountering a Flock of Birds and Subsequent Ditching on the Hudson River

US Airways Flight 1549
Airbus A320-214, N106US
Weehawken, New Jersey
January 15, 2009

NTSB/AAR-10/03
PB2010-910403

Aircraft Accident Report

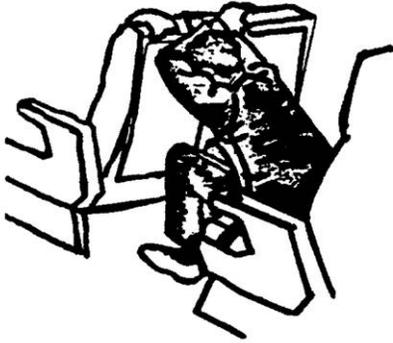
Figure 7. Passenger brace position shown in AC 121-24C.

The brace positions shown on the US Airways safety information card were in accordance with current FAA guidance on brace positions contained in Appendix 4 of AC 121-24C, which states, "in aircraft with high-density seating or in cases where passengers are physically limited and are unable to place their heads in their laps, they should position their heads and arms against the seat (or bulkhead) in front of them." (See figure 7.)

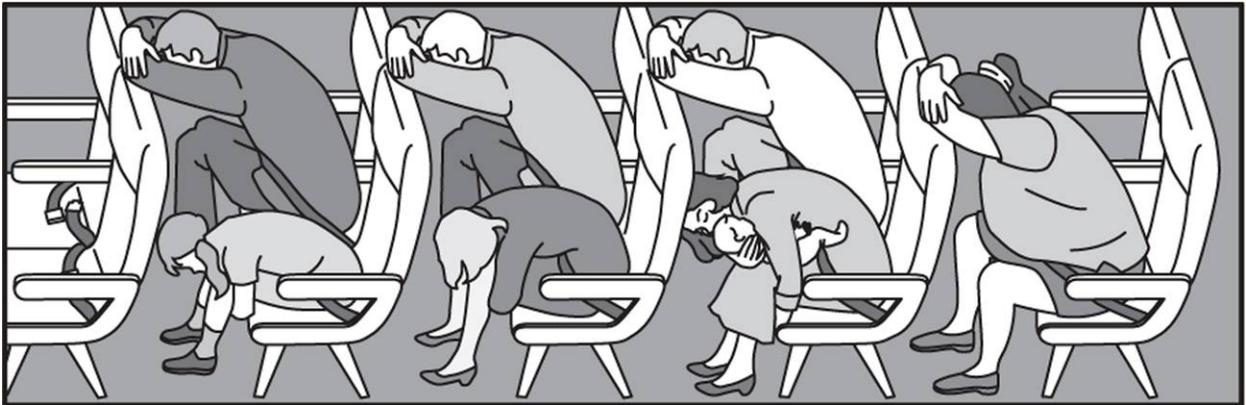
Figure 8. Passenger brace positions shown in the US Airways safety information card.

Of the four passengers who sustained serious injuries, three received their injuries during impact. The two female passengers who sustained very similar shoulder fractures both described assuming similar brace positions, putting their arms on the seat in front of them and leaning over. They also stated that they felt that their injuries were caused during the impact when their arms were driven back into their shoulders as they were thrown forward into the seats in front of them. The brace positions they described were similar to the one depicted on the US Airways safety information card, which is shown in figure 8.
